TECHNICAL REPORT ARCCB-TR-01003

**CHARACTERIZATION OF TANTALUM LINERS
APPLIED TO 25-MM AND 120-MM CANNON
BORE SECTIONS VIA EXPLOSIVE BONDING**

FEBRUARY 2001

**US ARMY ARMAMENT RESEARCH,
DEVELOPMENT AND ENGINEERING CENTER
CLOSE COMBAT ARMAMENTS CENTER
BENÉT LABORATORIES
WATERVLIET, N.Y. 12189-4050**

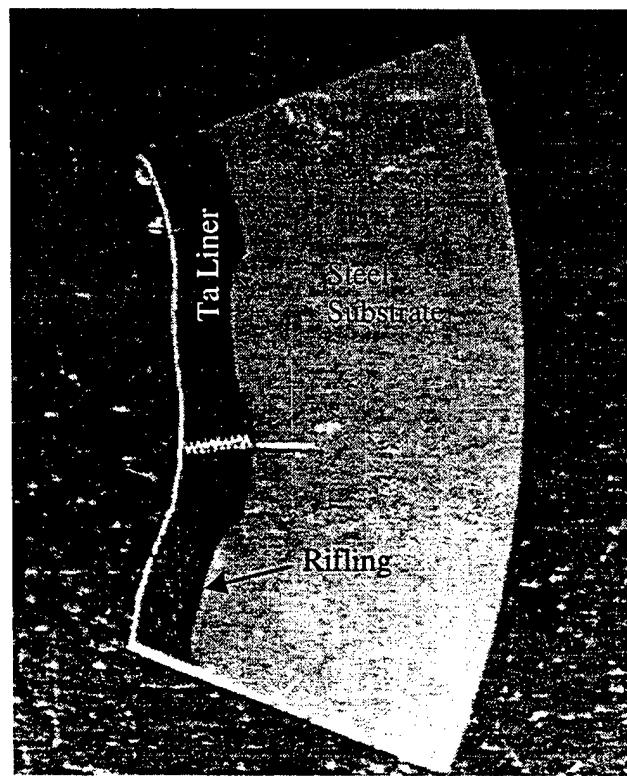
Upon stereoscopic observation, it was evident that the tantalum liner did not conform to the rifling profile (Figure 1). The thickness of the tantalum liner on the 25-mm specimen was approximately 1-mm or 0.040-inch (see Figure 2). Note that the dark features in the tantalum are artifacts left from the polishing. Polishing artifacts were embedded in the very soft liner material.

Figure 1. Stereophotomicrograph showing tantalum liner on 25-mm specimen.
Note that the coating did not conform to the rifling profile.

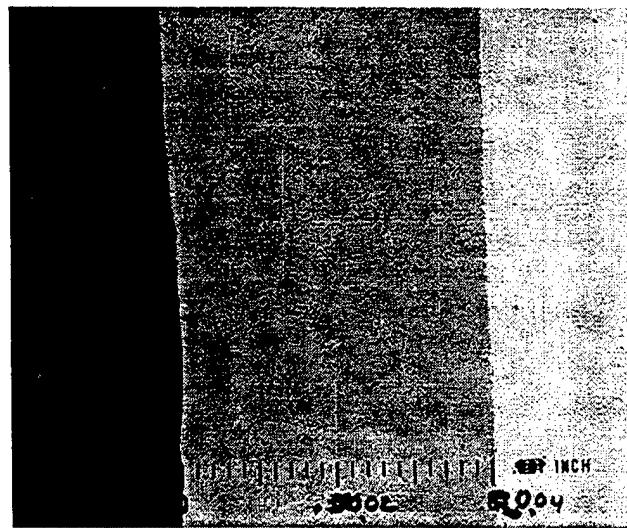
Figure 2. Optical photomicrograph showing liner thickness of approximately 1-mm (0.040-inch) on the 25-mm specimen.

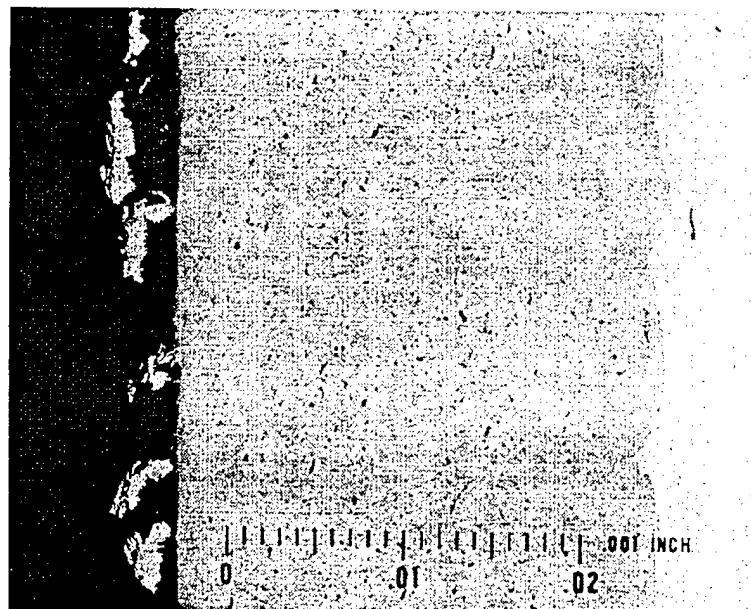
The liner thickness of the 120-mm sample was measured using an optical microscope. As can be seen in Figure 3, the coating is approximately 635- μ m (0.025-inch) thick. The dark features in the coating are artifacts left from the polishing. Polishing artifacts were embedded in the coating because it was so soft. For the 120-mm sample, a feature was observed on the surface of the liner that appeared to be in the shape of a weldment. It is believed that a welded tantalum tube was used for this process and that the weldment profile was transferred to the surface of the liner. This feature would require subsequent machining of the liner.

Figure 3. Optical photomicrograph showing coating thickness of approximately 635- μ m (0.025-inch) on the 120-mm specimen.

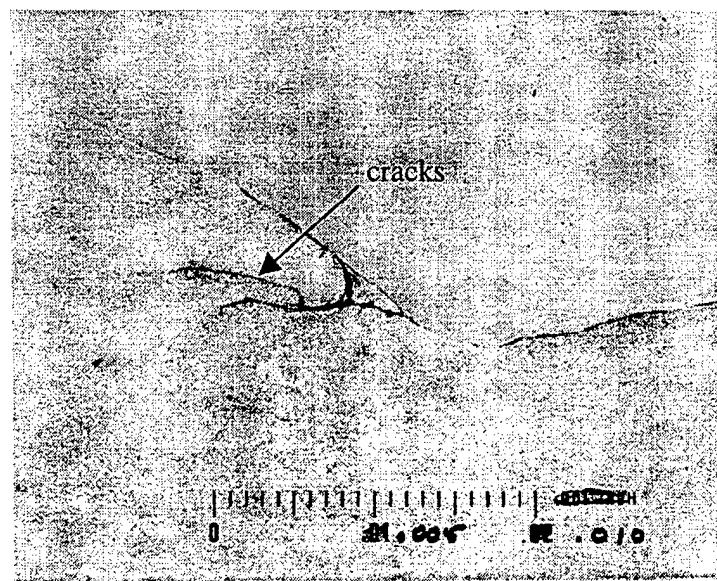
The microstructure of the steel substrate consisted of a quenched and tempered martensitic microstructure, as is typically observed in gun tubes (Figure 4). The rifling of the gun tube appeared to be rounded, suggesting prior firing damage in this gun tube. However, some medium caliber gun tubes can contain "gentler" rifling profiles. Additionally, there were cracks on one side of a land (Figure 5). The contractor later confirmed that, in fact, the gun tube had previously been fired.

Figure 5. Optical photomicrograph showing cracks in the side of a land (200X).

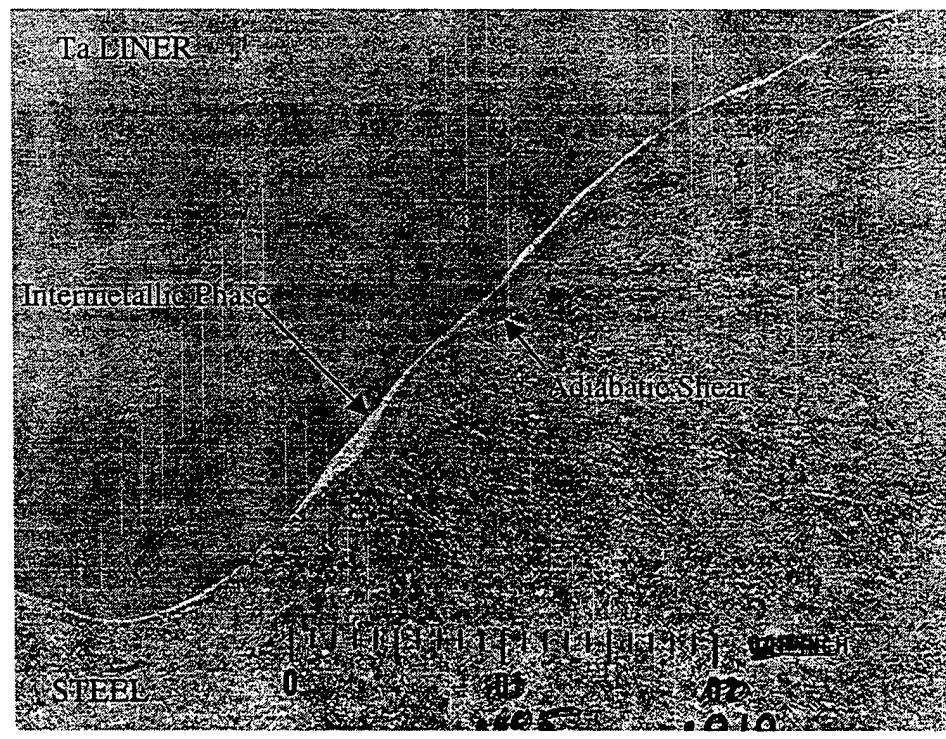
Plastic flow lines, due to the explosive bonding process, were observed in the steel. Also, a few isolated areas of what appears to be adiabatic shear were observed (Figure 6). Adiabatic shear occurs during dynamic loading. During dynamic loading, localized deformation and heating occurs along shear bands. In steels this localized heating can cause the formation of untempered martensite (refs 2,3). Untempered martensite is never desirable in a gun tube, being extremely brittle and adversely affecting fatigue life. However, without further testing, we are not able to quantify this effect. Adiabatic shear has been observed after in-bore detonation of gun tubes (ref 3), but not during normal gun firing.

An intermetallic layer (Figures 6 through 8) was observed along the majority of the liner/substrate interface in the 25-mm specimen. The intermetallic layer was thicker in the 25-mm sample than in the 120-mm sample. In the thickest regions of the 25-mm specimen, the layer was approximately 65- μ m (0.0025 inch) thick. Additionally, in many areas of this layer

Figure 6. Optical photomicrograph showing intermetallic phase at interface and adiabatic shear (200X).

According to the literature, explosive bonding can be achieved without melting and intermetallic compound formation. It is only when the process is too energetic that such undesirable features are formed (ref 4). If the pressurization can be controlled, then undesirable features such as these may be mitigated.

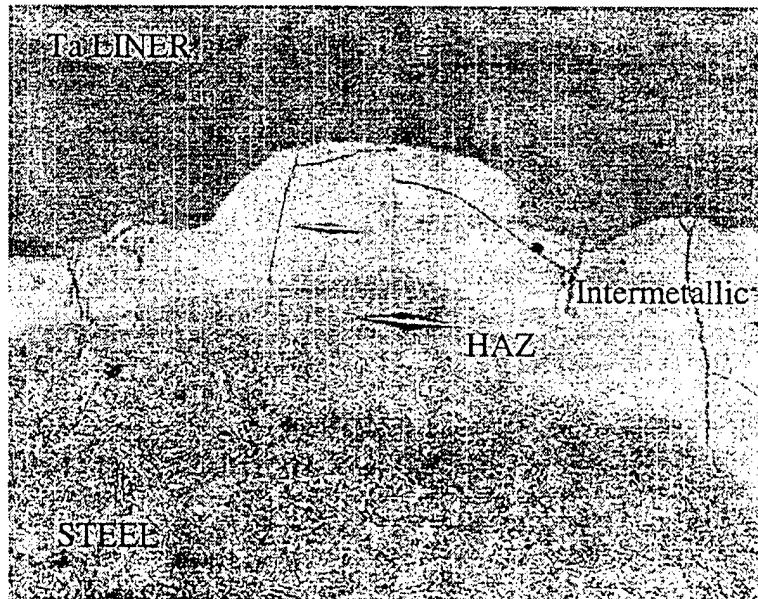
A heat-affected zone appears to have formed in some regions of the steel substrate (Figure 7). However, the microhardness in this zone was slightly lower than that in the base steel (Table 3). The softening in this zone could be due to overtempering or to redistribution of solute elements from the steel into the intermetallic phase at the interface.

Figure 7. Optical photomicrograph showing the cracked intermetallic phase at the interface and the heat-affected zone in the steel (500X).

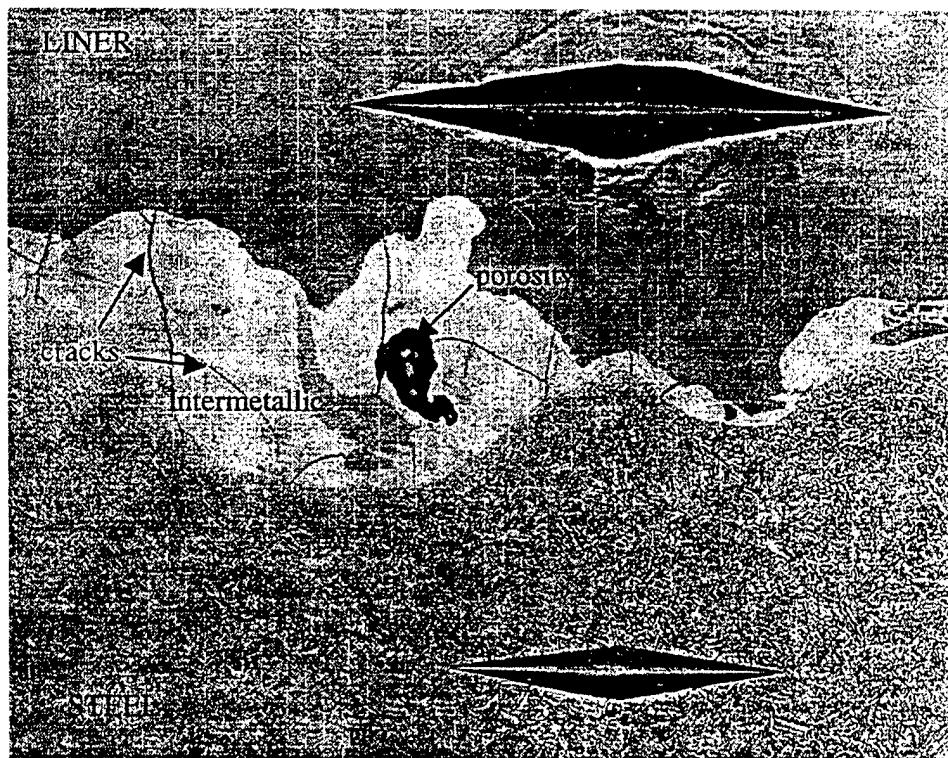
there were cracks observed (see Figure 8). The hardness of this layer was much harder than both the steel and the liner itself. An EDS spectra later confirmed this layer to be a tantalum/iron intermetallic compound (see "SEM and EDS" section); therefore, ***melting must have occurred at the interface***. Voids were also present along the interface (Figures 8 and 9). Many of these voids appeared to be on a preferential side of the "wavy" interface.

Figure 8. Optical photomicrograph showing the cracked intermetallic phase at the interface (375X). Note the porosity in the intermetallic and the difference in hardness between the coating and the steel substrate.

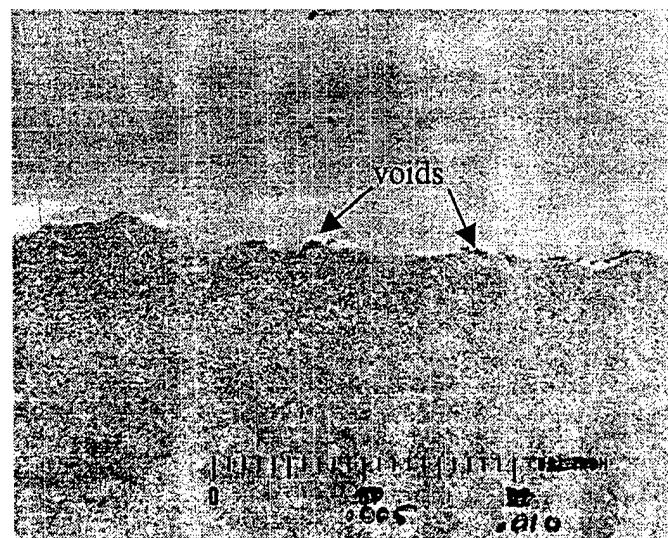
Figure 9. Optical photomicrograph showing presence of voids at the interface (200X).

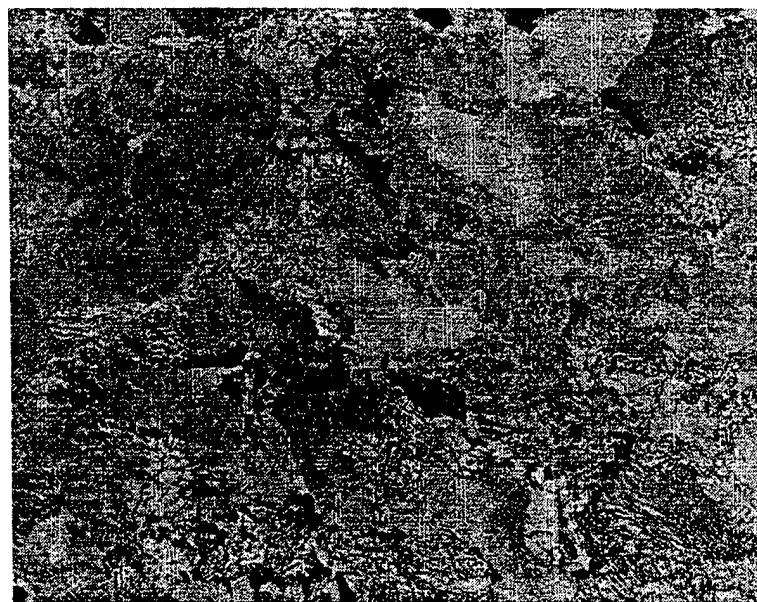
The microstructure of the steel substrate consisted of both fine and coarse pearlite and ferrite. This microstructure suggests that the steel was in the normalized condition when explosively bonded (Figure 10). The microstructure of the steel near the interface was "pancaked" due to plastic deformation induced by the explosive bonding process (Figure 11). As with the 25-mm sample, there was evidence of adiabatic shear in the 120-mm sample (Figure 12).

Figure 10. Optical photomicrograph showing normalized microstructure (pearlite and ferrite) of the steel (500X).

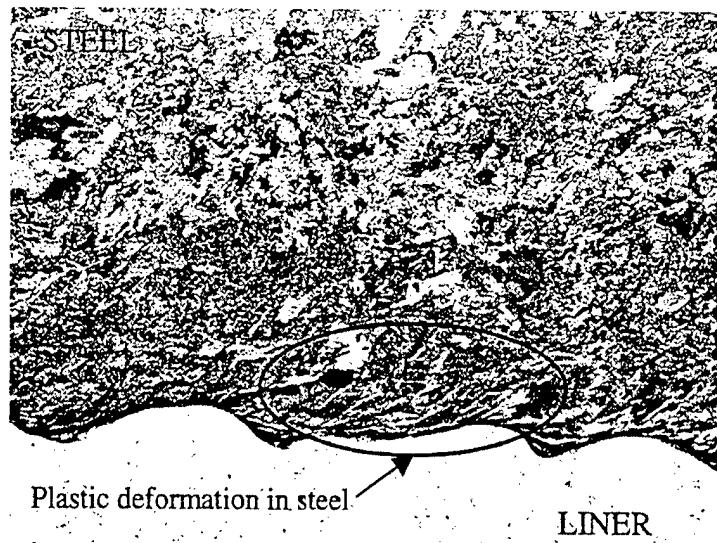
Figure 11. Photomicrograph showing deformation in the steel from the explosive bonding process (150X).

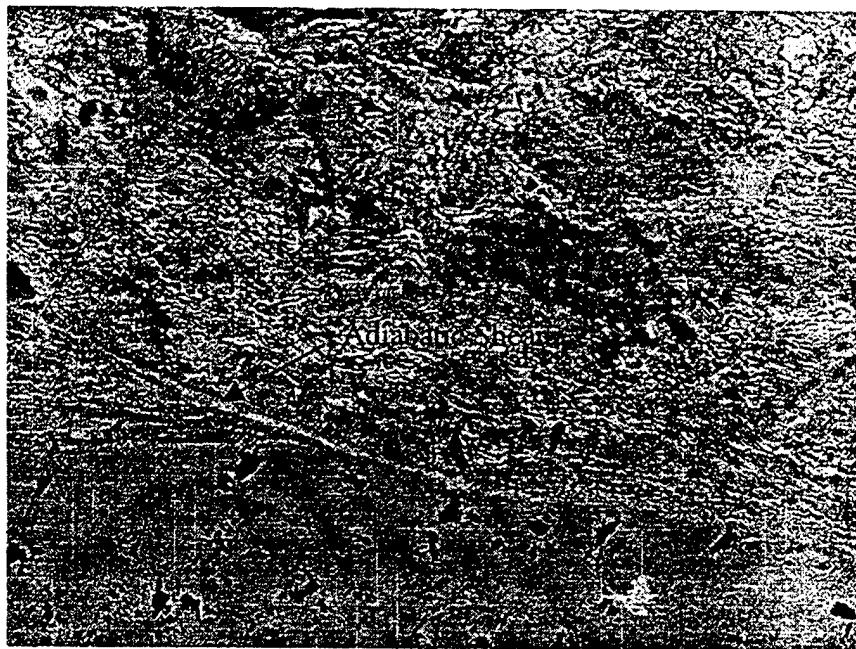
Figure 12. Photomicrograph showing adiabatic shear band in the steel (500X).

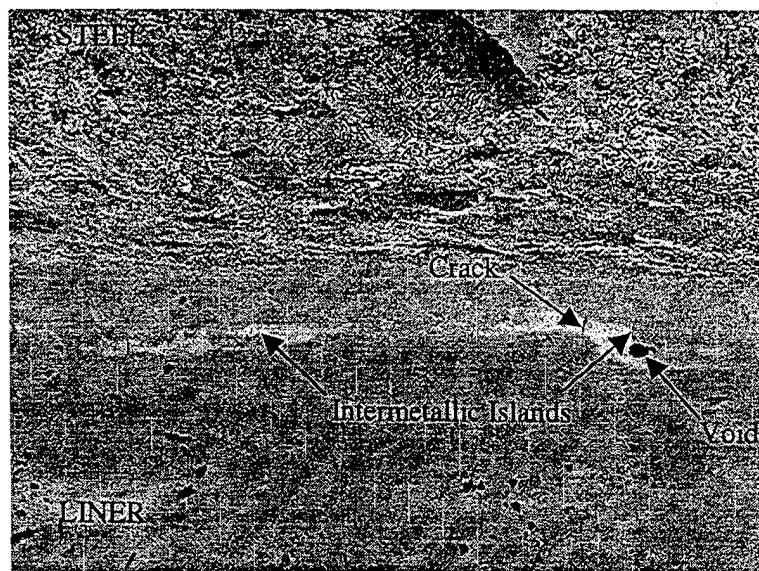
As with the 25-mm sample, the interface of the 120-mm sample also contained an interfacial layer. Although this layer in the 120-mm sample was not analyzed by EDS, it is believed to consist of the same iron/tantalum intermetallic as that observed with the 25-mm sample. The intermetallic was less thick in the 120-mm sample (< 25- μm thick; < 0.001-inch) than in the 25-mm sample. Much of the intermetallic contained cracks and voids (Figures 13 and 14). Additionally, much of the intermetallic was detached from the interface and present as "islands" in the tantalum coating. No voids were observed at the coating/steel interface.

Figure 13. Photomicrograph showing the presence of voids and intermetallic "islands" in the tantalum liner (500X).

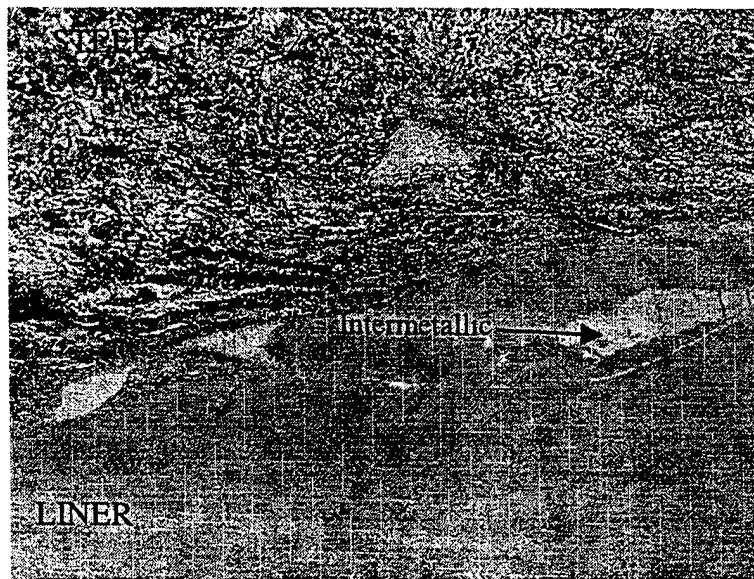
Figure 14. Photomicrograph showing crack intermetallic phase (500X).

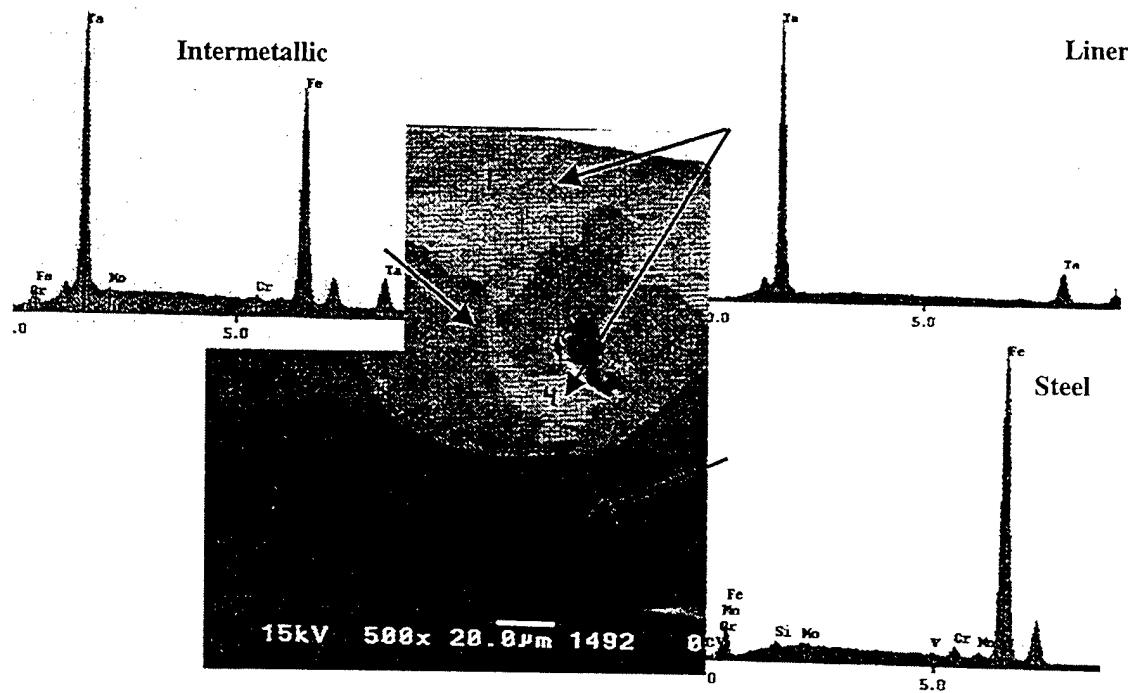
Figure 15 shows the results of SEM and EDS performed on the 25-mm specimen. Tantalum was observed in the liner (regions 1 and 4), tantalum and iron were observed in the intermetallic (region 2), and iron, along with alloying elements of gun steel, was observed in the steel (region 3). In region 2, the relative intensities of tantalum and iron in the intermetallic suggest that it is probably iron/tantalum (ref 7).

Figure 15. Results of EDS showing that the intermetallic consists of an iron/tantalum compound.
